Attachment A-1
Predesign Investigation

Continental Steel Superfund Site Contract 3—Geological and Geophysical (Markland Avenue Quarry Sediment) Investigations

PREPARED FOR: USEPA
PREPARED BY: CH2M HILL
DATE: October 11, 2001

Attachment A-1a
Sub-bottom Profiling Results
Continental Steel Superfund Site
Contract 3—Geological and Geophysical Investigations

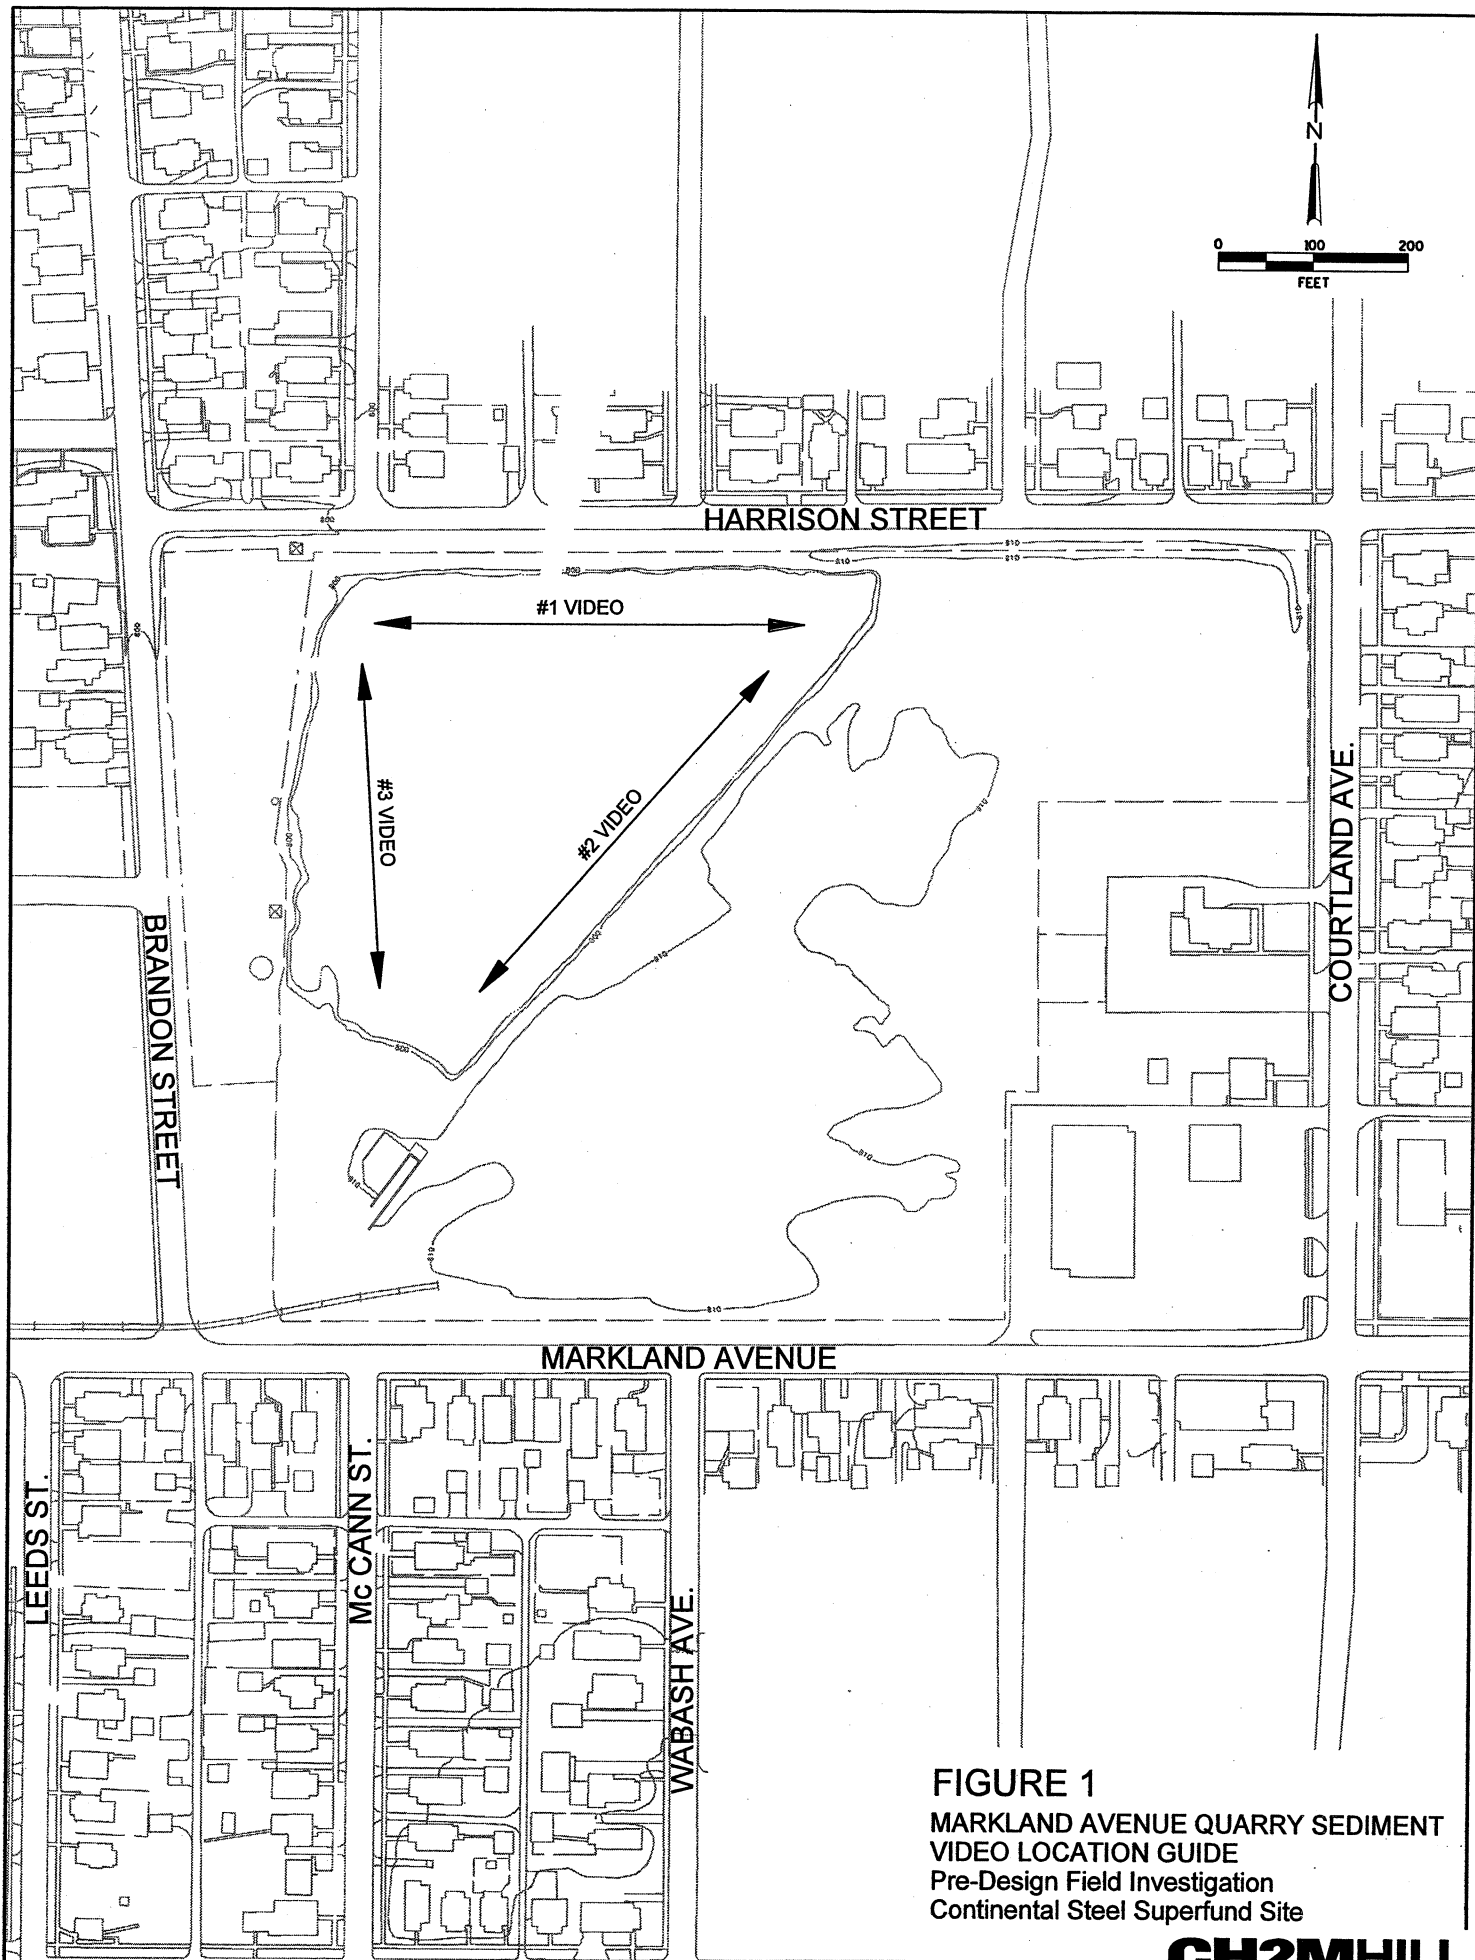
FIGURE 1
MARKLAND AVENUE QUARRY SEDIMENT
VIDEO LOCATION GUIDE
Pre-Design Field Investigation
Continental Steel Superfund Site

Using an underwater video camera, on August 20-21, 2001 a single diver and a two-person boat crew videotaped the bottom profile to document the features and conditions of the quarry bottom. Three paths running the length of the longest sides of the quarry were selected for videotaping. The first path, documented in "Video No. 1," runs parallel to the northern edge of the pond in a relatively straight line immediately south of Harrison Street.

The second path, documented in "Video No. 2," runs parallel to the eastern edge of the pond and is positioned at about a 45° angle toward the northeast. The third path, documented in "Video No. 3," runs parallel to Brandon Street and covers the western edge of the pond. The video path locations are shown on Figure 1.

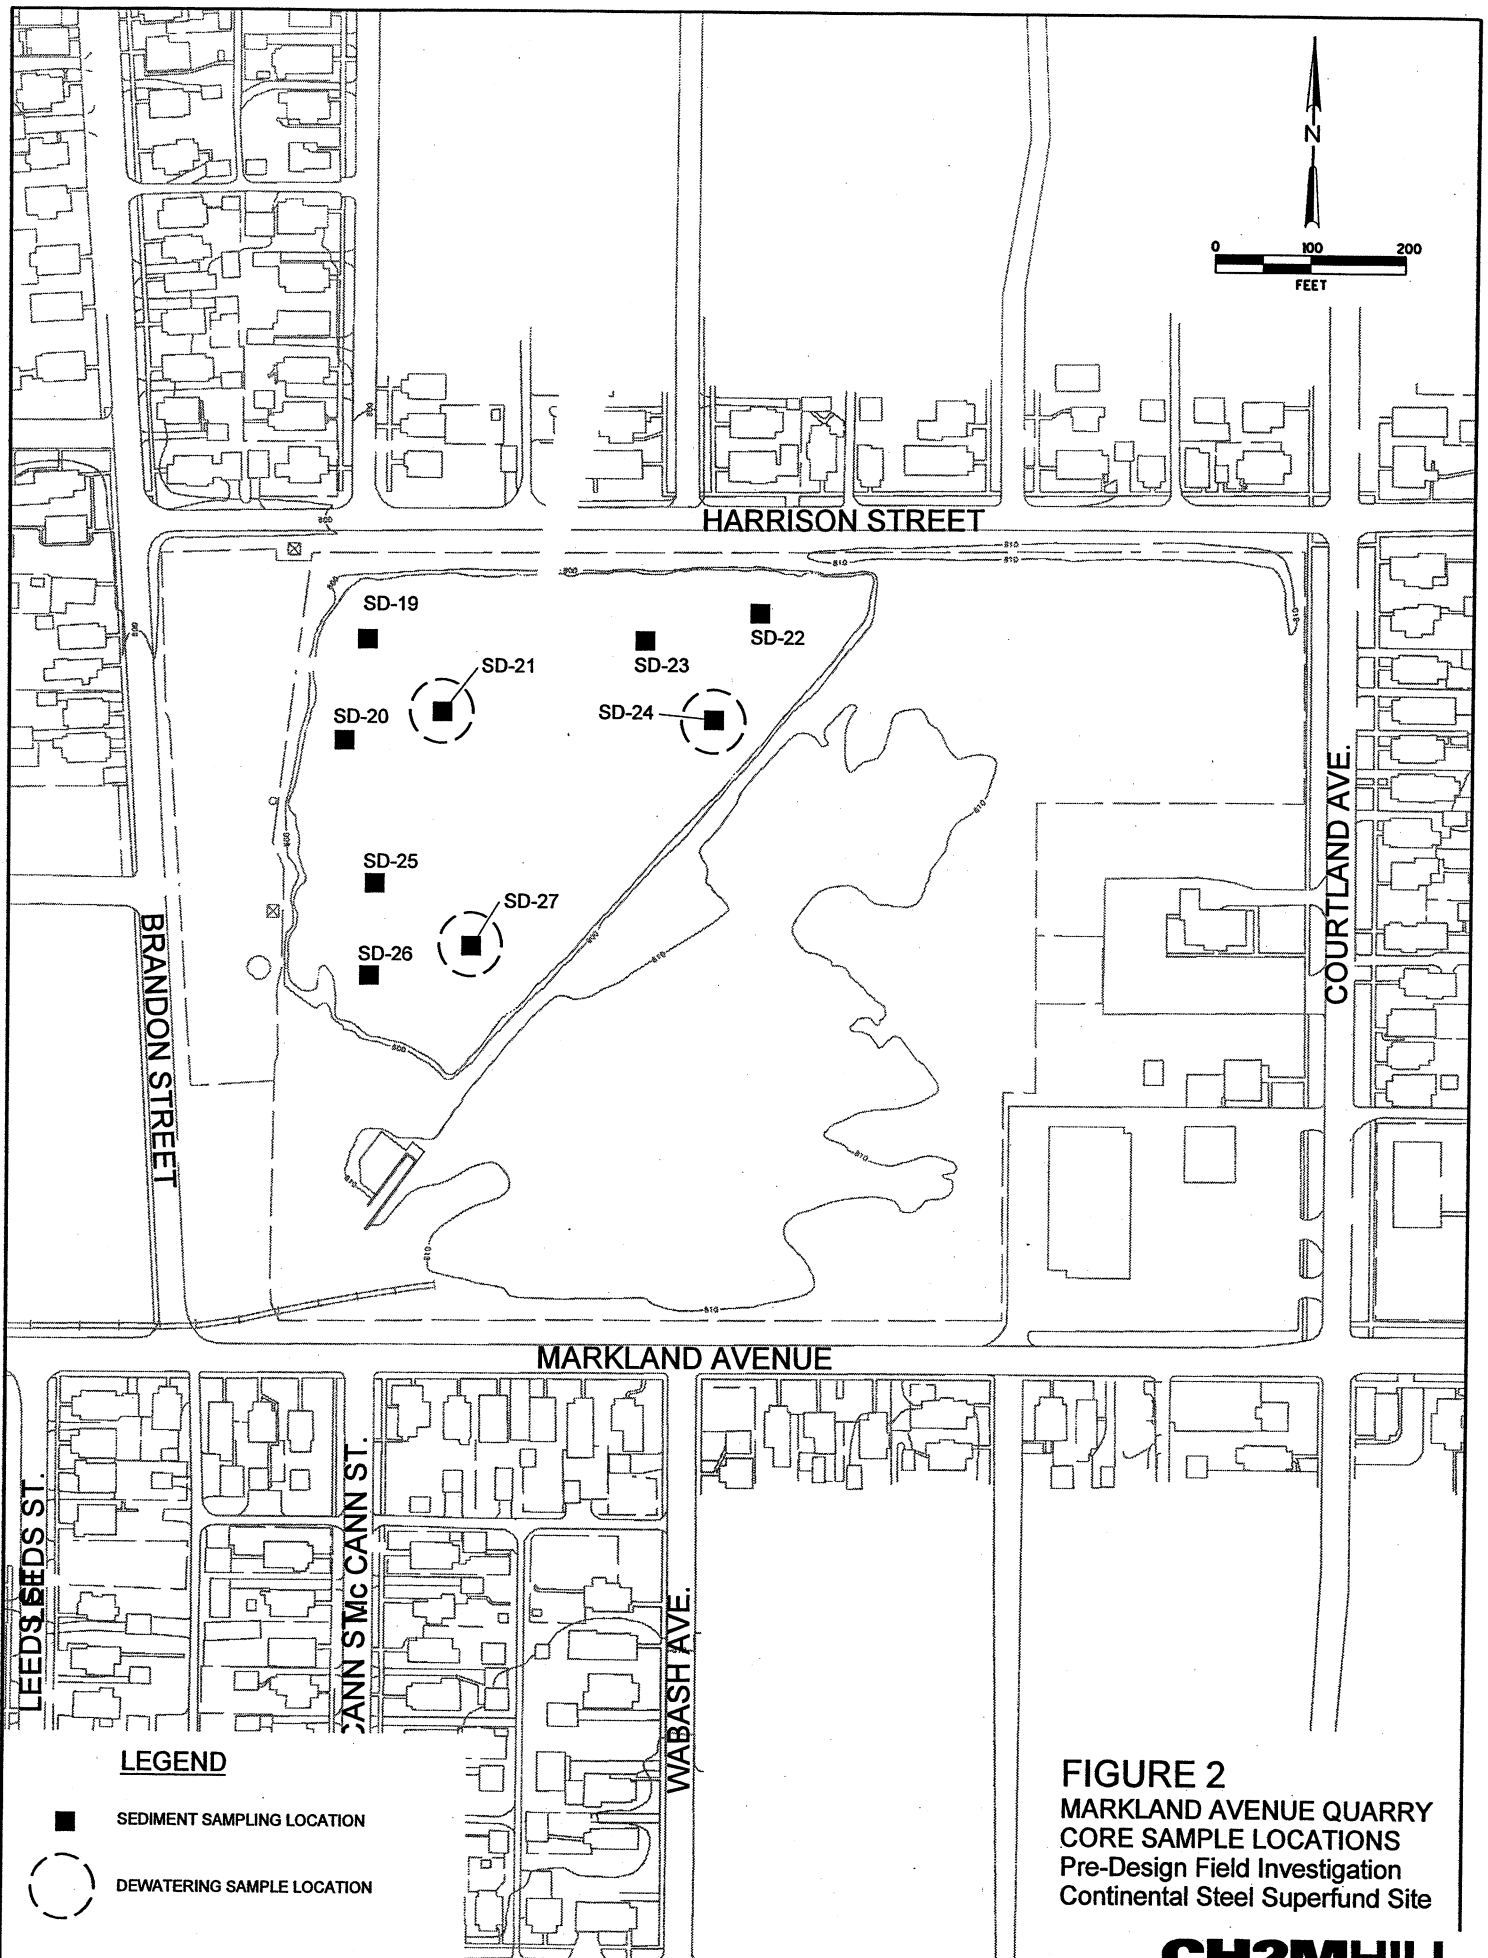
FIGURE 2
MARKLAND AVENUE QUARRY
CORE SAMPLE LOCATIONS
Pre-Design Field Investigation
Continental Steel Superfund Site

The first area, which covered about 150 square feet of the northwest section of the pond, was sampled on August 21, 2001. The second area, which covered about 150 square feet of the northeast corner of the quarry, was sampled on August 22, 2001. The third area, which covered about a 100 square foot area of the southwest corner north of the boat ramp, was sampled on August 23, 2001.

Locations of sediment samples for chemical analyses are shown on Figure 2. The sample dates, times, methods, analyses, and comments are summarized in Table 2.

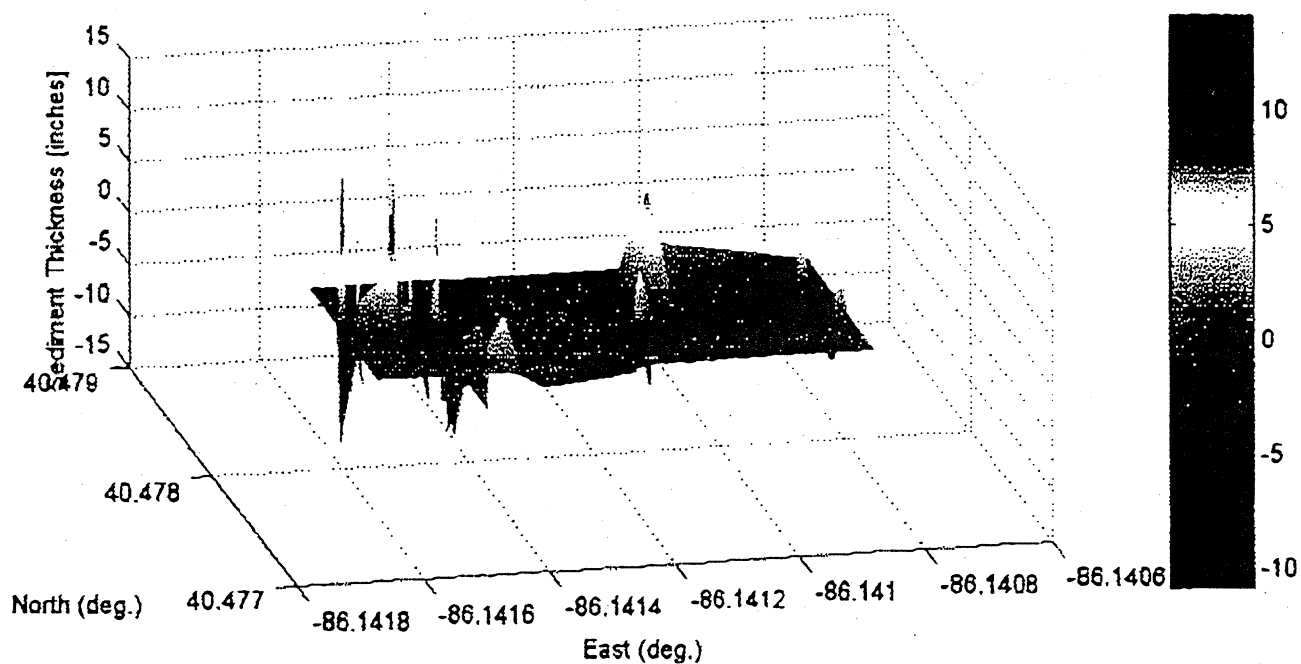
FIGURE 5

Representative raw data collected at the site and stored in the data logger is presented in **Figure 4**. A mathematical model of the sediment depths as differences from the average plane is presented in **Figure 5**. The reference plane for the graph is in longitude/latitude while depth of sediment is in inches.

Based on the lake bottom profiling survey, ISI estimates that the average thickness of the sediments is 24.3 in and varies from 13.3 in to 38.4 in. Assuming an average area of the lake bottom to be 100,000 ft², the total volume of sediments is estimated to be 7,500 yd³.
